SIO Shipyard Representative Bi-Weekly Progress Report		
Project: AGOR 28	Contract No.: N00014-12-C-0305	Shipyard: Dakota Creek Industries
Prepared by: Paul D. Bueren Scripps Institution of Oceanography (SIO) 297 Rosecrans St. San Diego, CA 98106	Date: 18 May 2016	Program Officer: Robert (Tim) Schnoor Office of Naval Research 875 Randolph St ONR 321 Arlington, VA 22203-1995
Distribution Statement A: Approved for public release; distribution unlimited.		Report No. A002.099

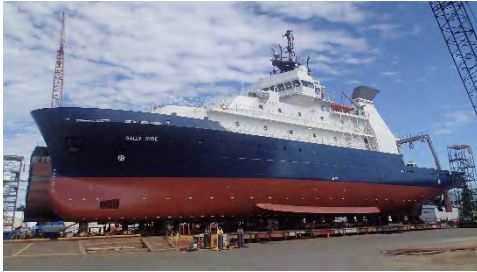
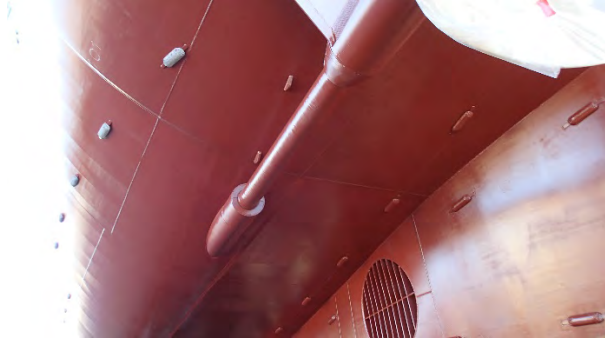
- Underwater Coating – Failed areas prepped, primed and two coats of AF applied. Entire underwater hull received one coat of red AF. All markings painted in white. One coat AF to all transducers except for the three ADCP windows.

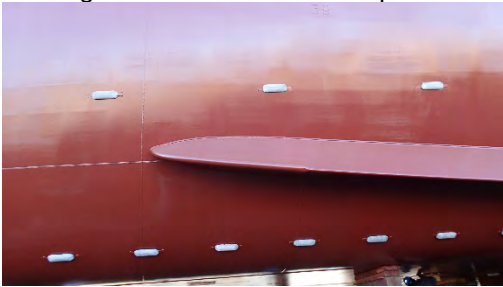
- Freeboard Coating – Hull above the waterline cleaned, prepped and painted as needed. Name, draft marks and plimsol lines painted white.
- Bilge Keel Mod – Work complete. Affected area faired in and painted.

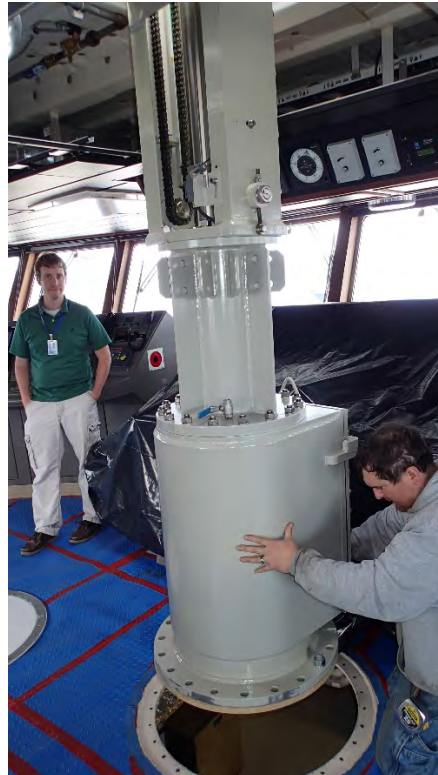
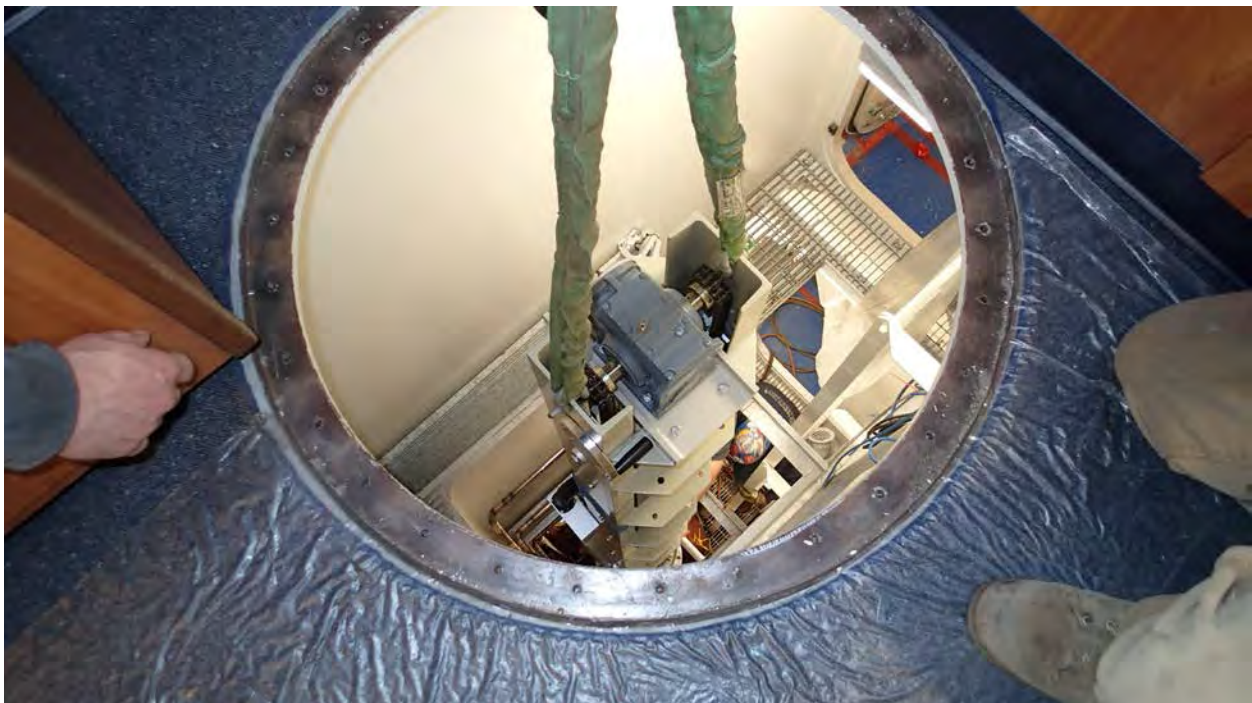
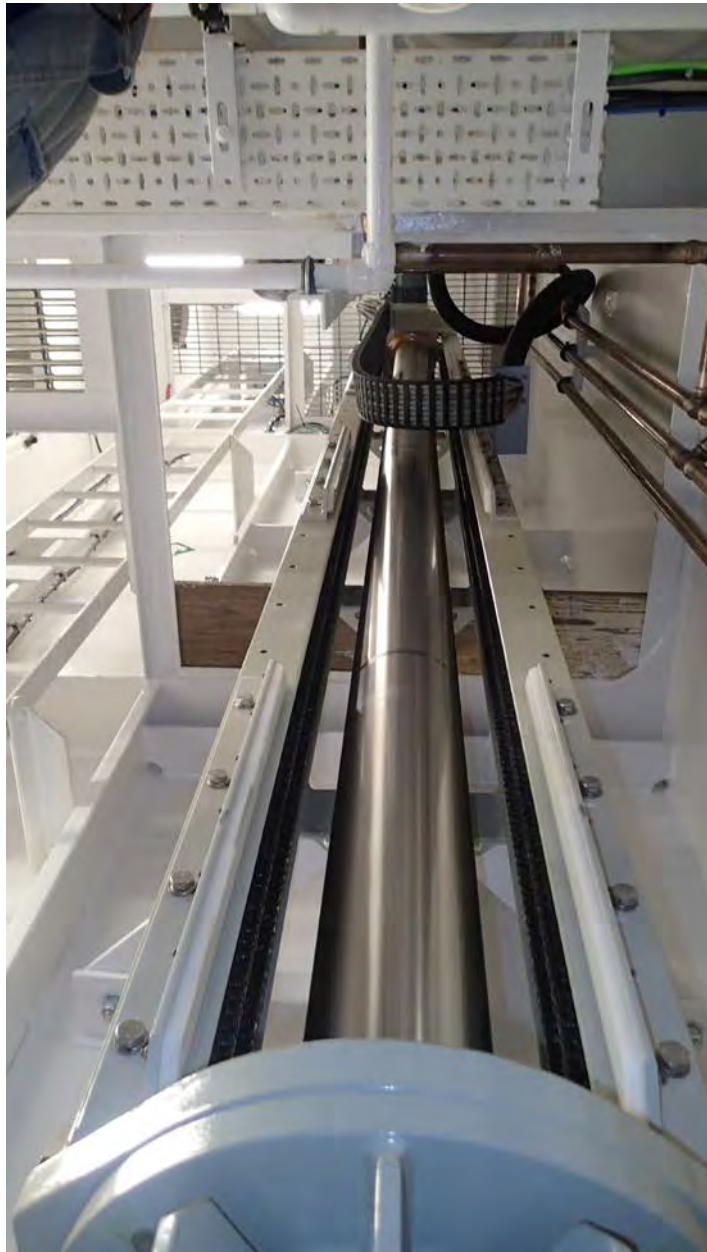
Figure 3 HiPap Install 28 April

- HiPAP Installation – The HiPAP has been installed. Yard continues to make the interconnects and is currently installing the hydraulic lines to the sea valve actuator. The actual installation went very smoothly.

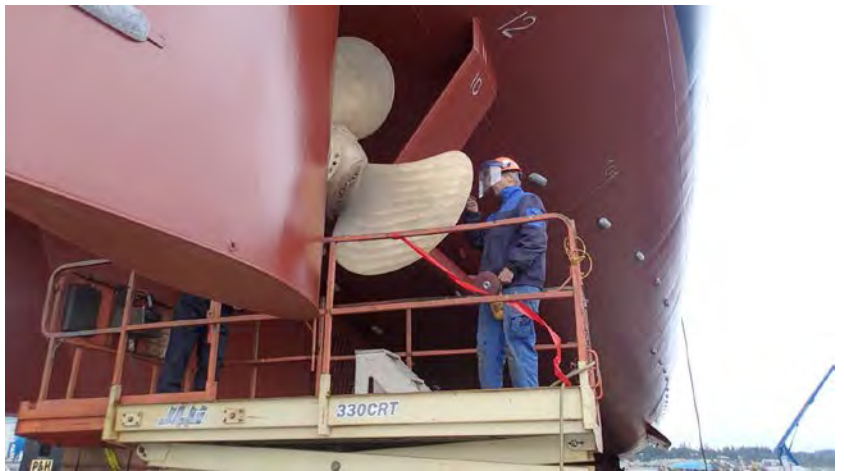
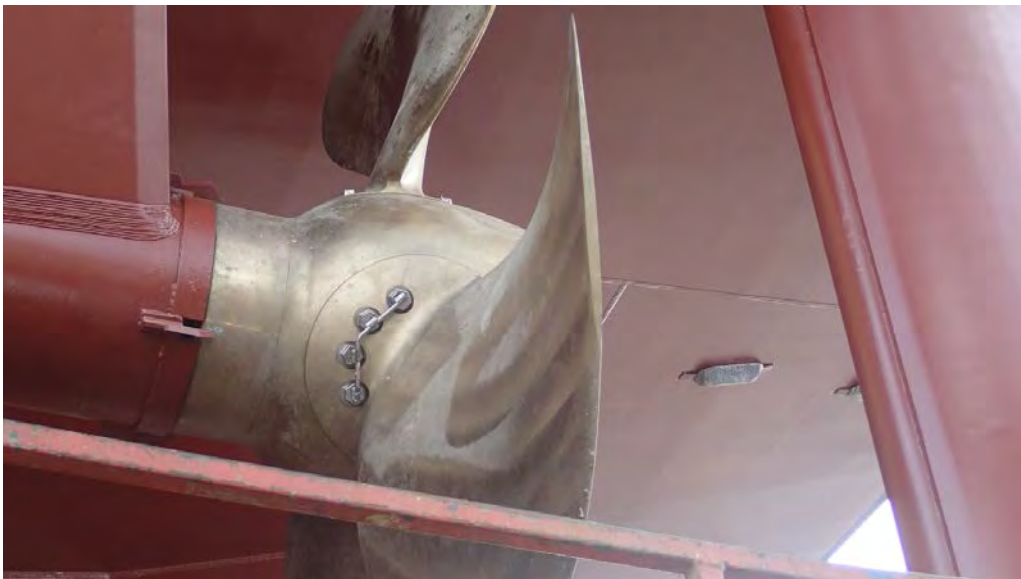
- Propeller Tips -
The local Hundested vendor and a technician from Norway were on site. They broke the edges on the blade tips on both props. The tech had half a dozen machined gauges that he used to ensure that the final profile was correct. The blade tips now have a more rounded profile compared to the original flat end with sharp 90-degree angles on the suction and trailing edges.

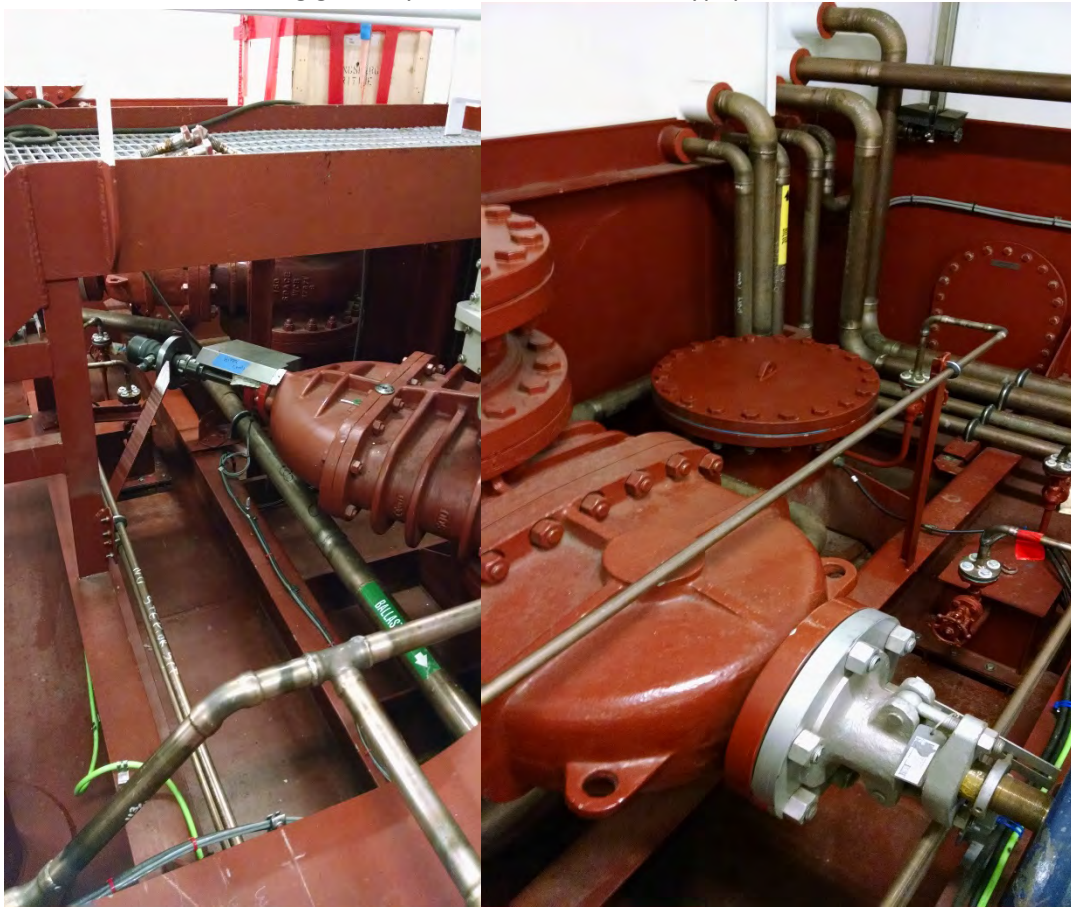
Transducer Room looking good, hydro-electric valve for Hypap .
